AMERICAN LOCATOR[®] MAGAZINE

VOLUME 33 ISSUE 5
November 2019

Another Day, Another DIRT(Y) Report: Reported Damages Reach All-Time High in 2018

CASE STUDY HDD PULLS BACK 26 DUCTS

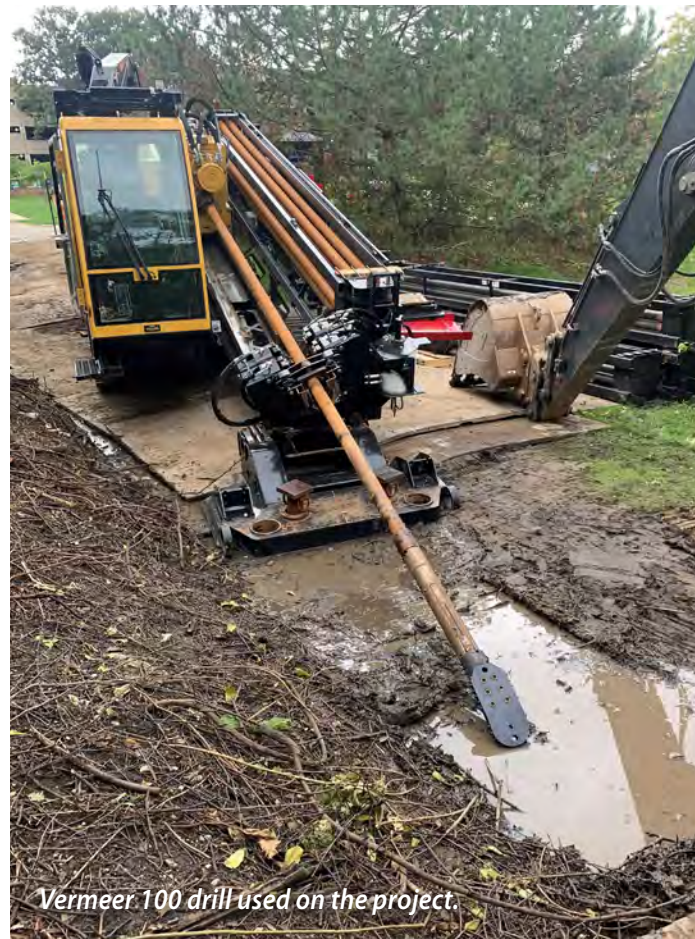
Vermeer 100 drill used on the project.

Pathways for the drill and track hoes were cleared, and the surface was lined with mats. Silt fence and erosion controls were installed. The Vermeer 100 was the directional drill used on the project. It generates 100,000 pounds of pullback force and 14,000 pounds of rotational torque. This drill had plenty of power for the drilling, reaming and pullback operations.

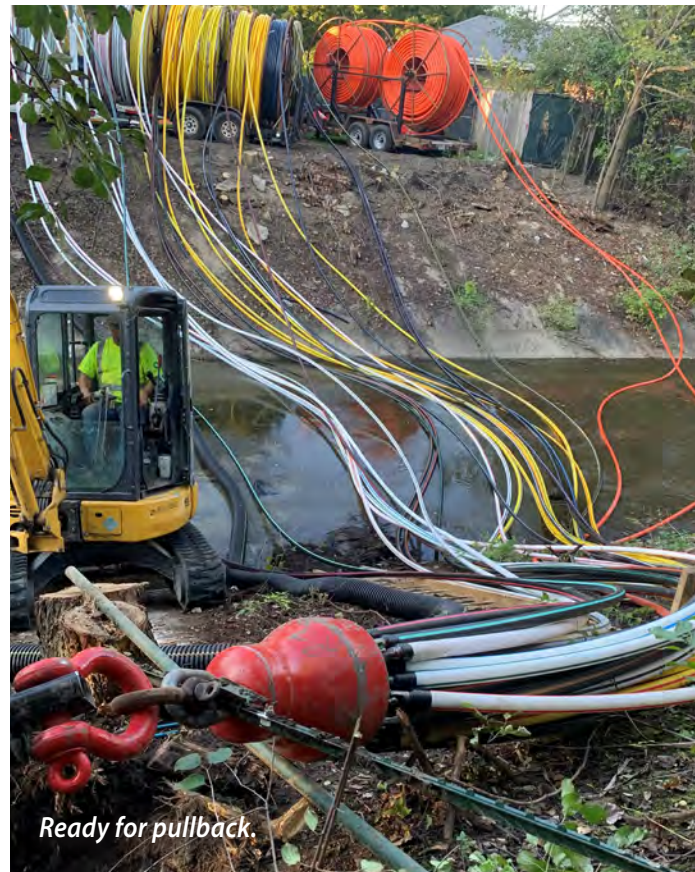
Ready for pullback.

4. Conduit reels, conduit ready for pull back

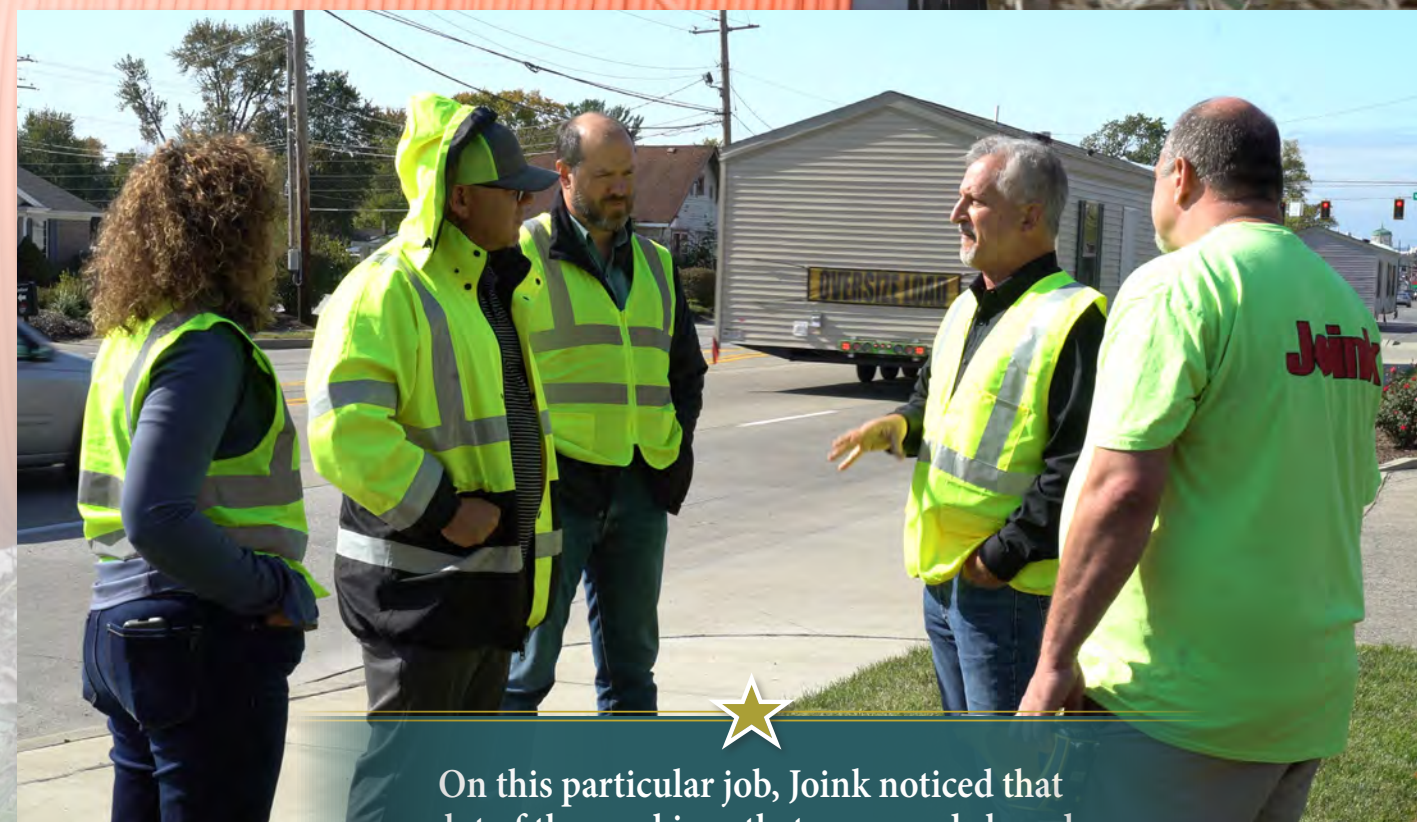
Background: Joink crews were having trouble confirming locate readings onsite. Tracer wire was found not to be the issue. **Foreground:** Mike Parilac speaks with field team from Joink while investigating the source of anomalous locate readings.

On this particular job, Joink noticed that a lot of the markings that were made based on what the locating instruments showed were not that accurate, with some of the readings showing that their conduit was several feet away from the marked location on the ground. Staking University and Planet Underground TV President Mike Parilac traveled down to Brazil, IN to see exactly why they were experiencing inaccurate locates. Once there, Mike had the Joink team look for both a peak and a null response from the locator. The peak and null responses were approximately three feet from each other. "Our issue with this locate is that things other than our tracer wire are also being energized. Something else made of metal is taking some of our transmitter's energy, and the field that this non-target conductor produces is affecting our field on our target conductor—the tracer wire. We call that a not-round field, and a not-round field means inaccurate," Mike told Joink personnel Timothy McCombs, Patrick McCombs, and Matt Loughmiller.

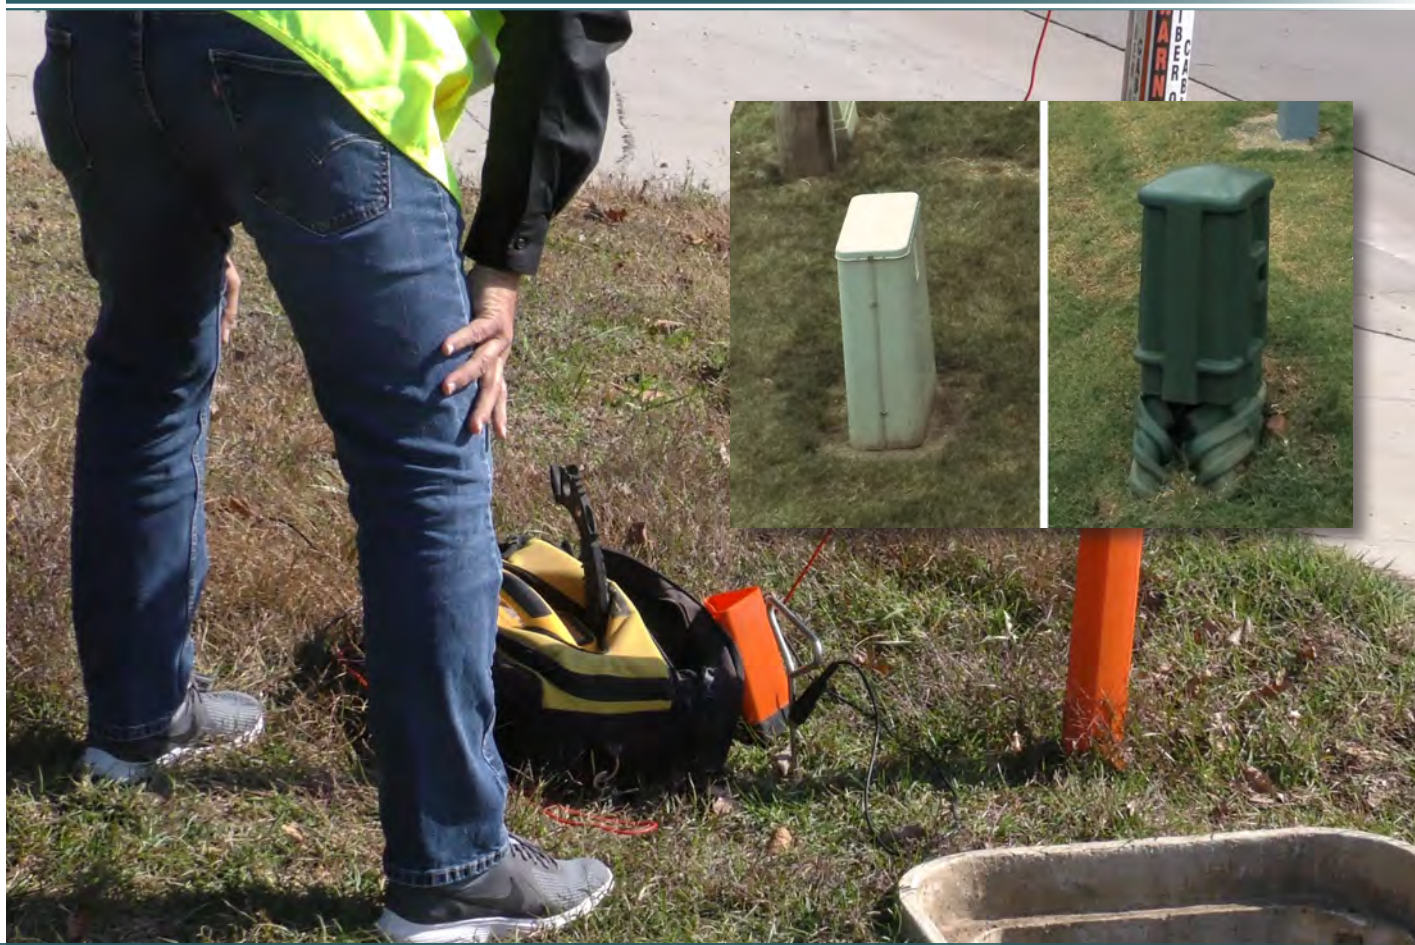
Top: Mike Parilac hooks up his transmitter to test the tracer wire viability on the job, which checks out ok.
Top Right: These above ground telephone structures indicate the presence of parallel-positioned telephone duct.
Bottom: The 4-foot ground rod (left) was used before being switched with a portable ground rod (right).

This made sense because there was a telephone duct within the vicinity of the fiber conduit they were looking for. There were multiple telephone structures that were above ground that provided a clear visual of how the nearby telephone ducts could interfere with the locate. Mike then suggested that they try to read the depth at each mark using a method called depth validation. This is where you go over one of the marks and lift the locating instrument about a foot off the ground to see if the depth reading becomes a foot deeper. The first time they tried this over one of the marks, the depth reading on the screen did not change at all, which means that the accuracy of the mark could not be trusted.

At this point, the next step was to change the grounding system of the transmitter. Initially, the transmitter was grounded to a driven four foot ground rod within the hand hole which could have

resulted in the signal latching on to cables of an adjacent phone duct that weren't being targeted. Due to less metal mass, changing to the portable grounding device that comes with the locating instrument would potentially reduce the amount of signal on the telephone cables. This procedure did reduce the gap between the peak and null response, although not by much.

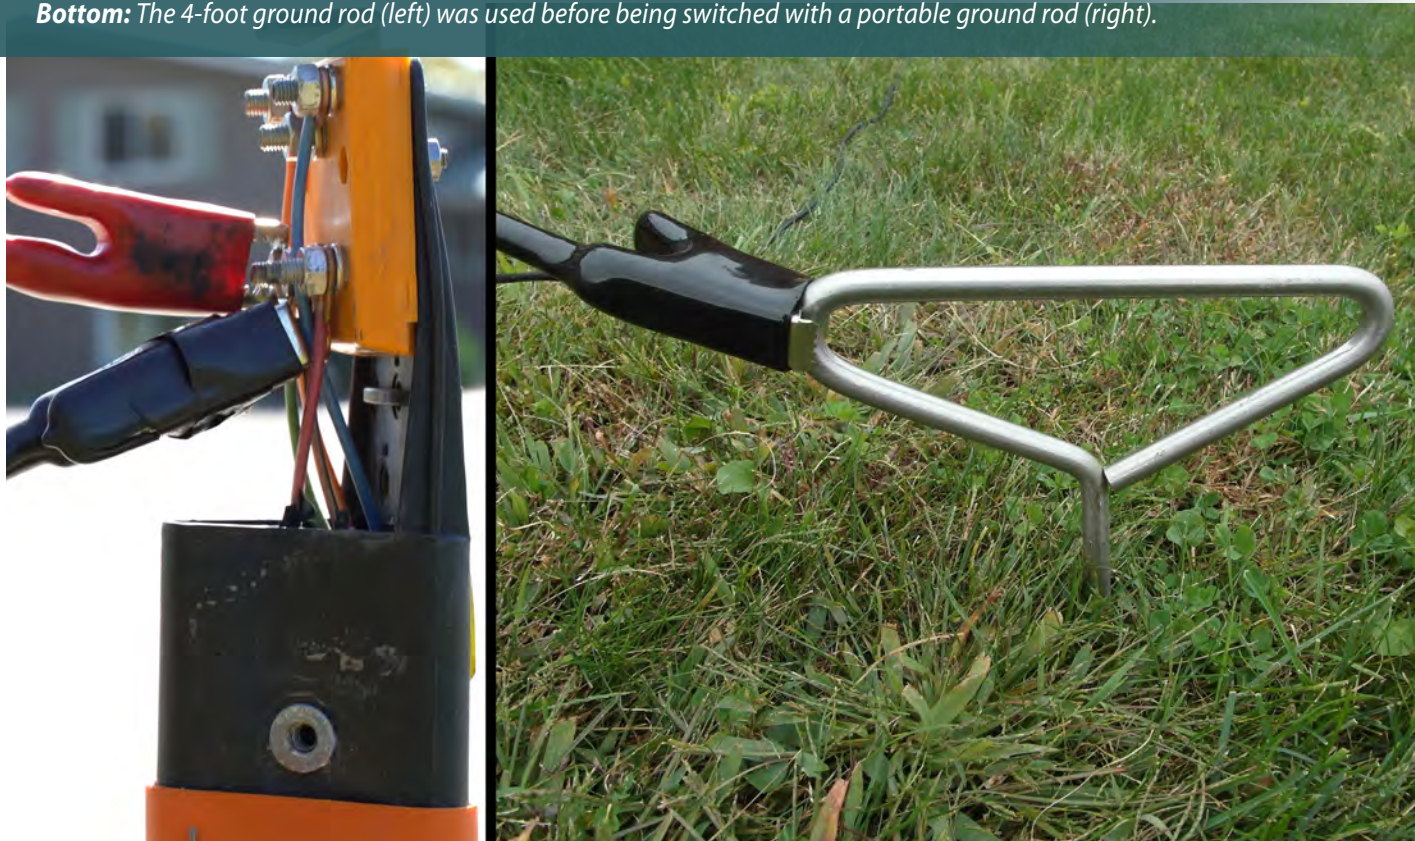
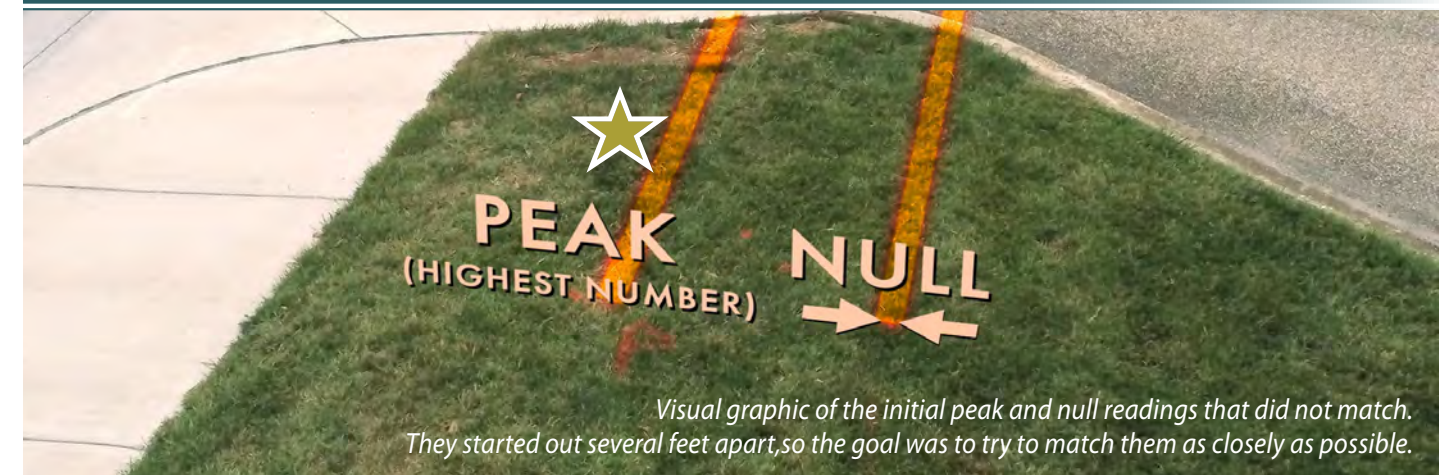
Visual graphic of the initial peak and null readings that did not match. They started out several feet apart, so the goal was to try to match them as closely as possible.

The next thing tried was changing the frequency. The frequency from the first couple of tries was at 9.5 kHz, so Mike had Joink drop the frequency to 512 Hz, which was the lowest available transmitter frequency. Lowering the frequency helped, but the peak and null readings still did not line up as hoped. Mike then tried using another manufacturer's receiver set to 512 Hz. However, after trying the new equipment, it was clear that locating equipment wasn't the issue, because they both were having the same exact problem pinpointing the utility.

"We've changed the grounding system and we've changed the frequency. I'd like to move the transmitter [down to the other end] and come back and see what our results are." After moving the transmitter to the end point and sending the signal the opposite way, and trying both a higher and lower frequency, the gap between the high peak number and the arrows of the null reading did shorten up quite a bit (around four inches or so), but it was still about a foot or so off from lining up. At this point, there wasn't much else that could be done as far as changing the equipment setup. "From a direct hookup standpoint, we've done everything we can here. Nothing else to try; this is the best we can do. "But when peak and null disagree, peak is almost always closer to being right than null," Parilac pointed out to the crew.

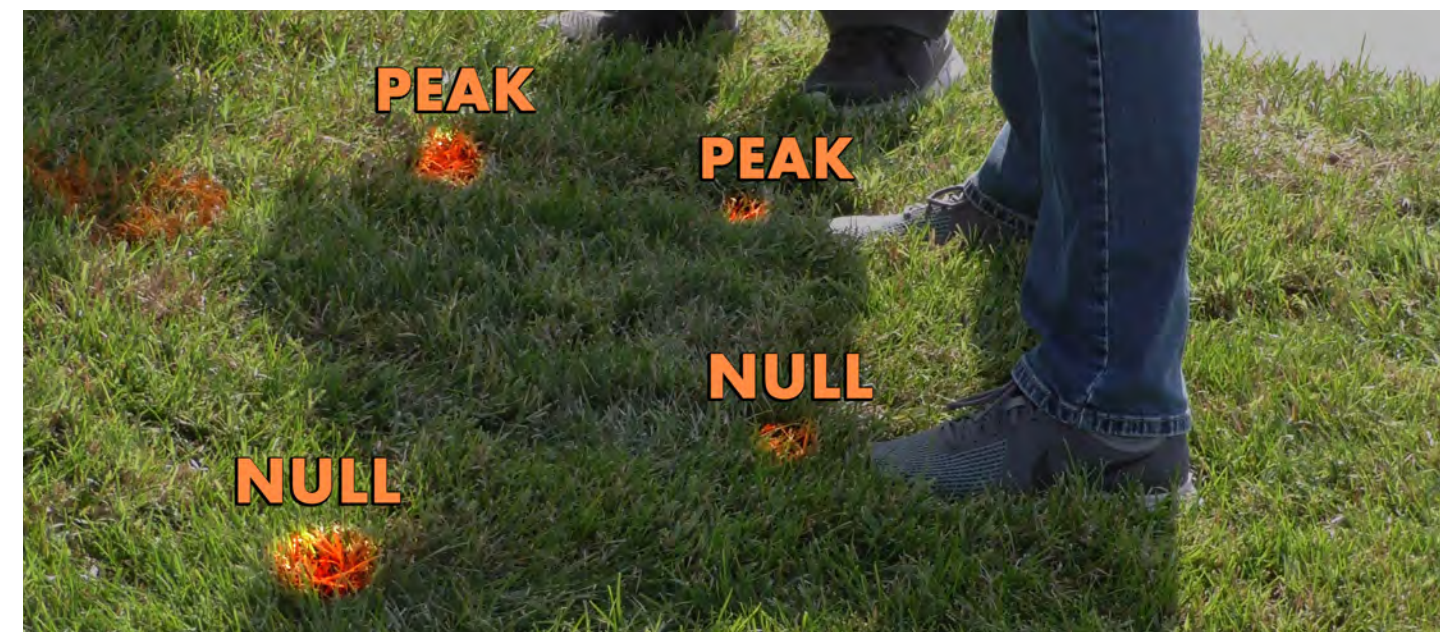
Sometimes there is too much metal in the locate area that becomes energized by the transmitter. In this case, the metal was a group of copper telephone cables running parallel with the tracer wire. After moving the transmitter to the end point and sending the signal the opposite way, and trying a lower frequency, the gap between the high peak number (right foot) and the arrows of the null reading (left foot) did shorten up quite a bit, but it was still about a foot off from lining up.

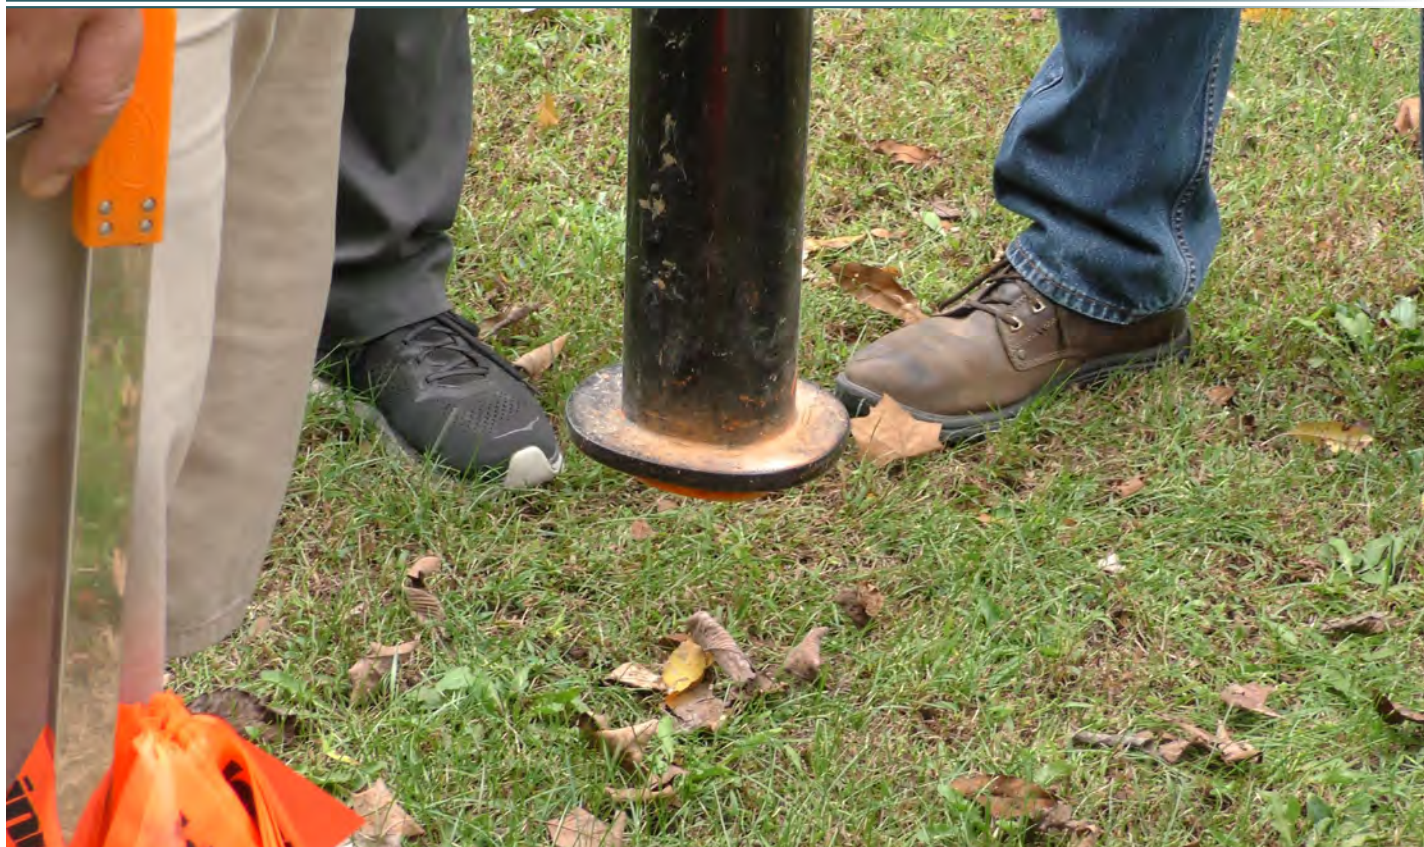
Patrick lifts the receiver to read the depth at a second elevation to validate the initial depth reading.
