## A Field Study of Factors that Affect Depth Calculations

Author: Dennis Prezbindowski, Ph.D., GPR Instructor and Trainer with Staking University

# Case Study of Rapid Lateral Changes in GPR Substrate Velocities

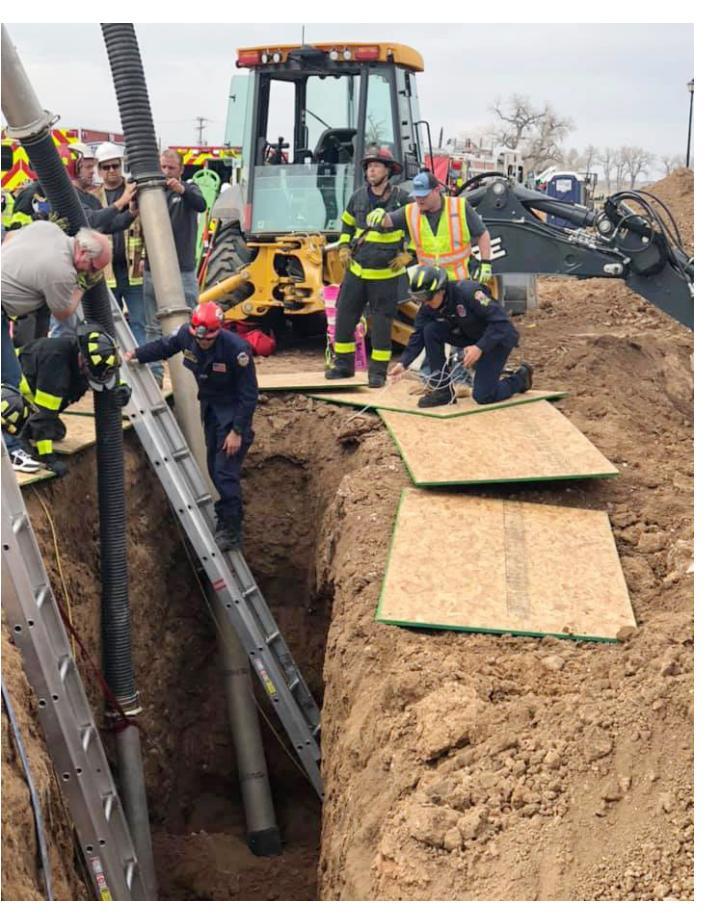
Above: Two workers were trapped after a trench collapse in Windsor, CO. Rescuers attempted to provide oxygen via PVC tubing. Photo courtesy: Windsor Severance Fire Rescue.

ied but survived for hours after workers got a PVC pipe to him to help him breathe. The other worker was buried on top of the one using the PVC pipe and was not responding to rescuers when they arrived. Ultimately, first responders were unable to reach either worker in time before they died.

Early reports indicate that none of the three trenches involved in these fatal incidents were protected by sloping, shoring, or shielding with trench walls or trench boxes. The Occupational Safety and Health Administration confirmed it was investigating the deaths in Windsor and in Marysville, but did not elaborate any further. According to an OSHA factsheet, trenches five feet or deeper must have some sort of protective system in place unless the excavation is being done in stable rock. Scott Allen, an OSHA spokesperson, said that OSHA will take up to six months to complete their investigations, issue citations and propose penalties if violations are found.

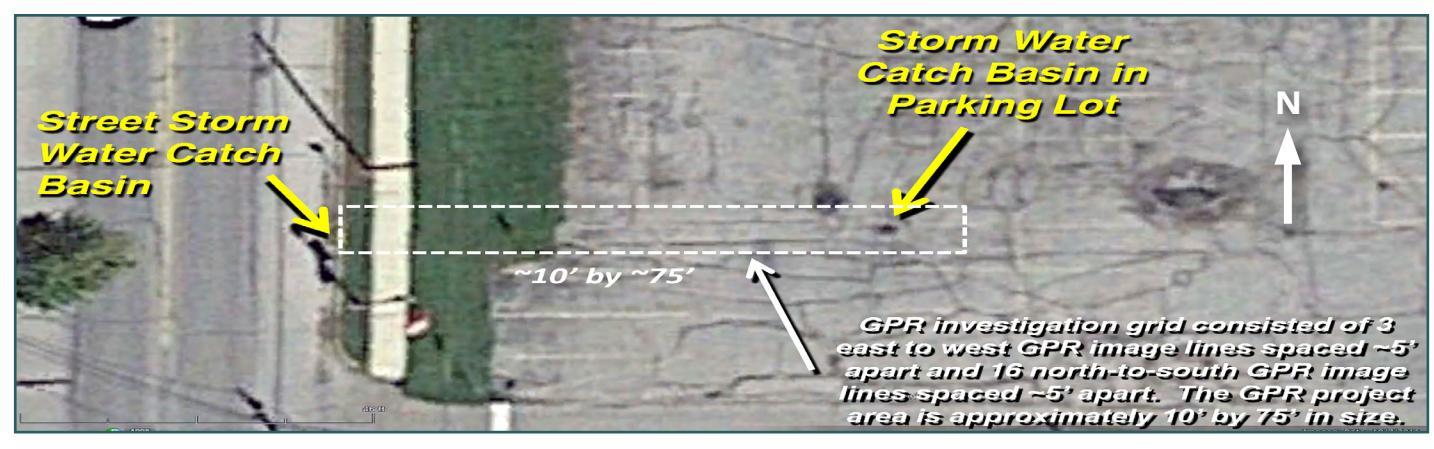
Fig. 1: Google Earth photograph of a Northeast street corner in North Webster, Indiana. An extensive GPR survey was conducted to locate underground utilities and structures before the start of a construction project. This short article focuses on a small, detailed GPR grid imaging of a stormwater pipe that runs from the street stormwater catch basin to the stormwater catch basin located in the parking lot.

I conducted a 10' by 75' GPR imaging grid project with 5-foot line spacing (Figure 1) along the axis of a previously imaged, continuous stormwater pipe that runs from the edge of a street to a stormwater catch basin located in a parking lot (Figures 2, 3 and 4). This stormwater pipe had a 12" diameter and a visible initiation and termination points (Figures 2 and 3). The depth to the top of this metal stormwater pipe at the catch basin measured 30 inches (Figure 4).

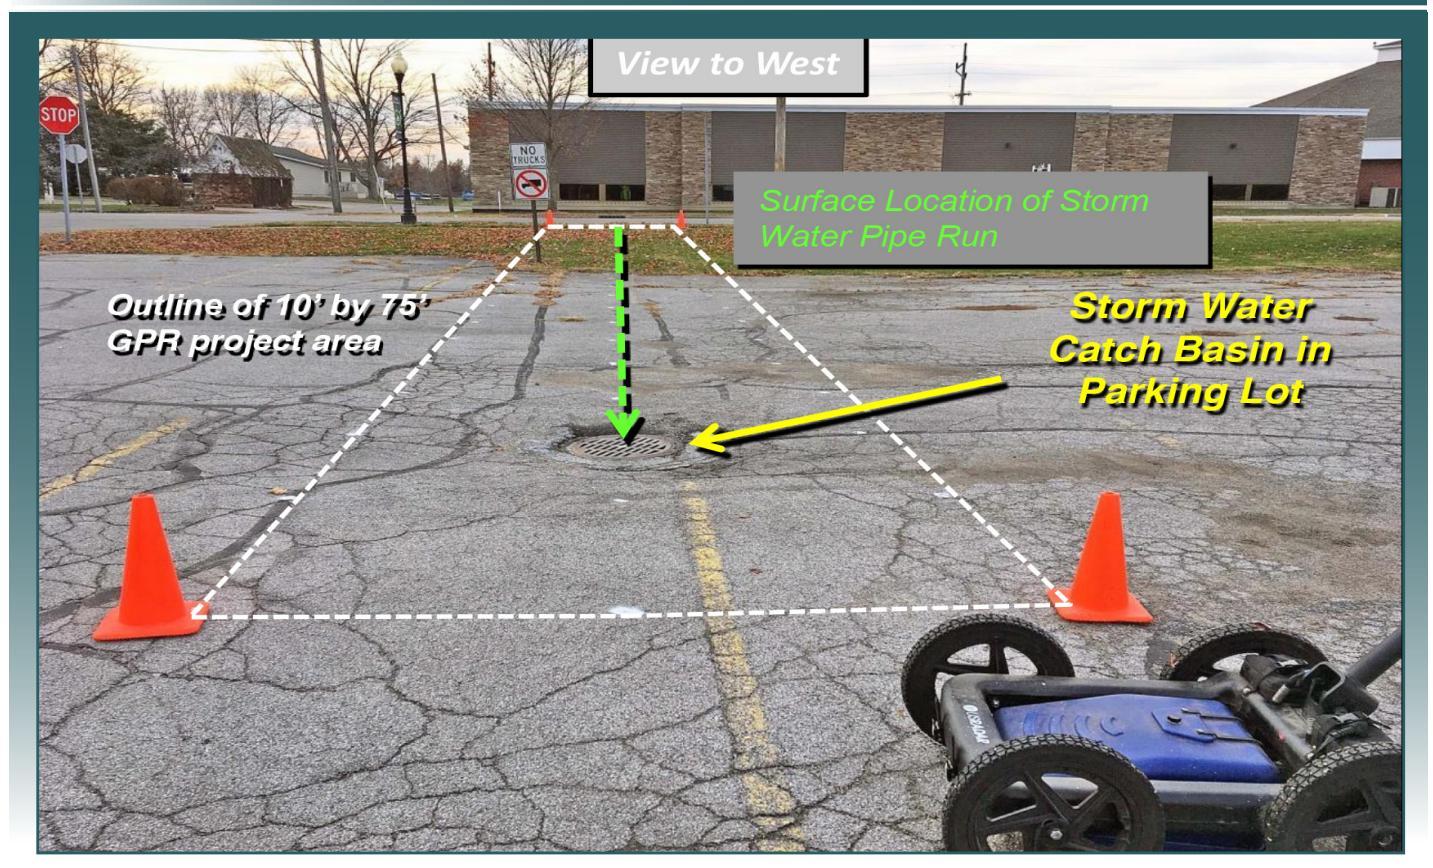
Fig. 2: Outline of the particular GPR grid project area (10' by 75' white dashed area) is shown. The green dashed arrow illustrates the approximate surface location of the subsurface, 12" diameter, metal, corrugated stormwater pipe running from the street to the storm water catch basin in the parking lot.

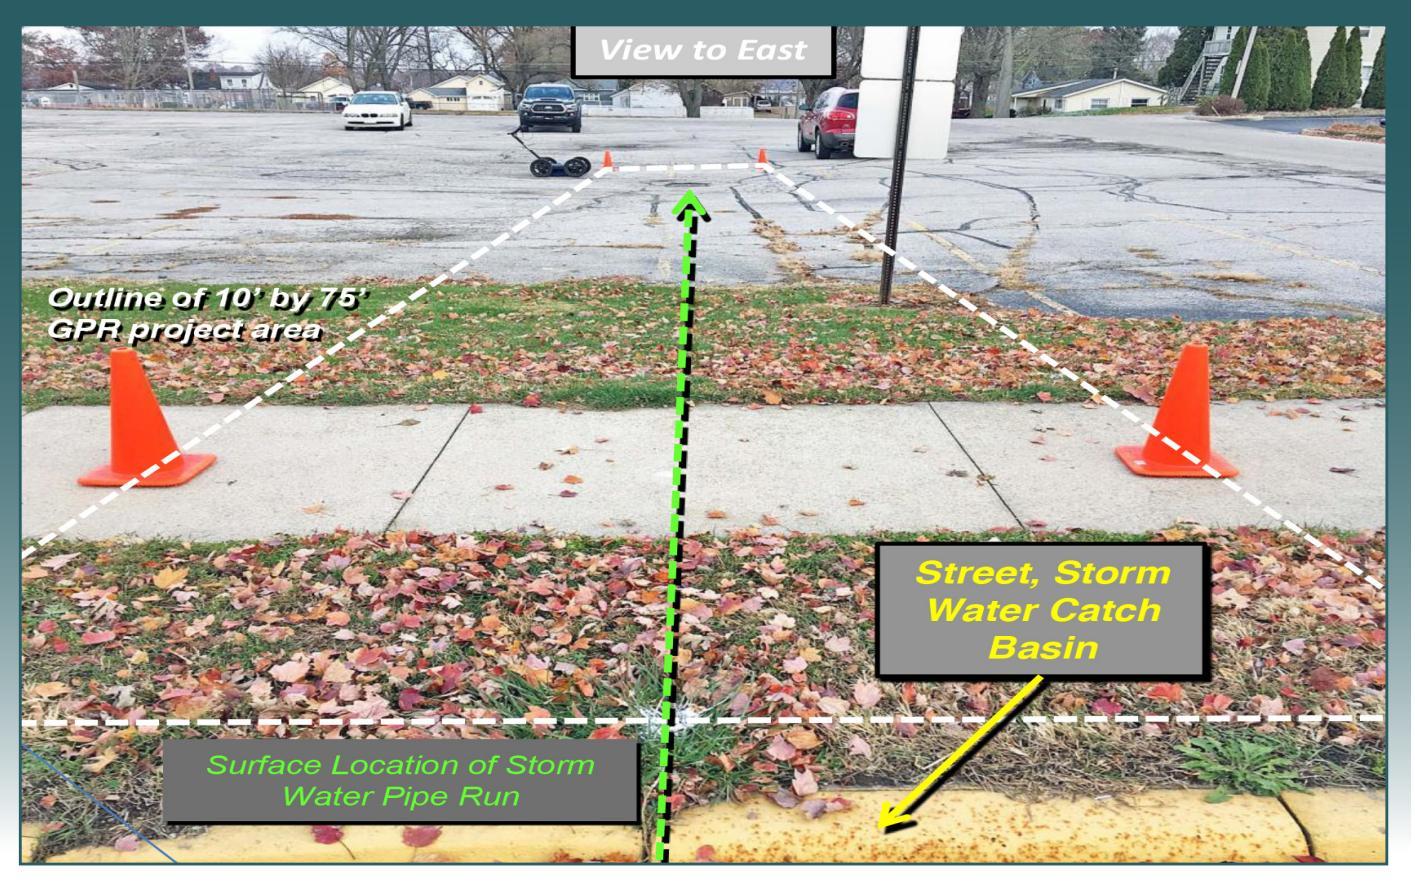
Fig. 3: Picture of the origin point of the 12" diameter, metal corrugated stormwater pipe running from the street to the storm water catch basin in the parking lot.

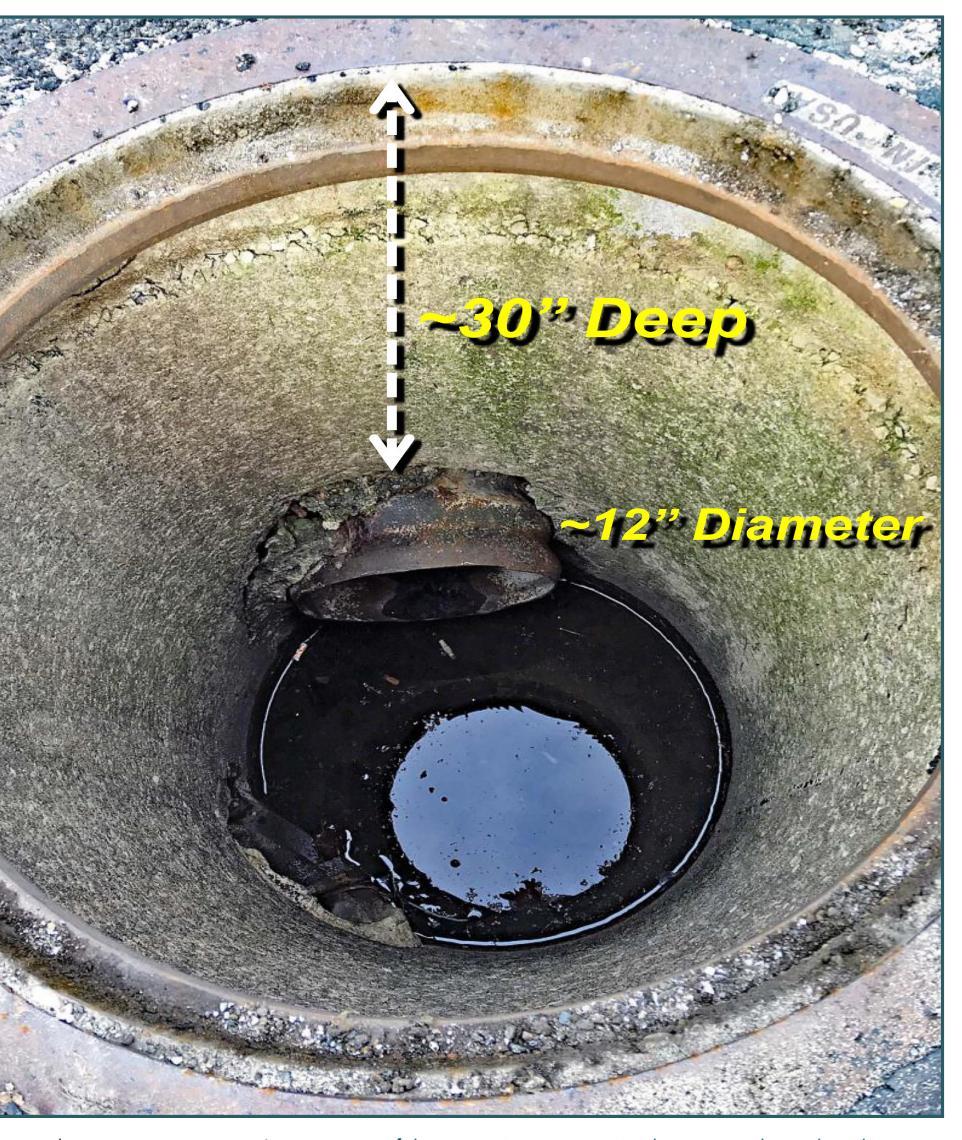
Fig. 4: Picture of the open "Storm Water Catch Basin" in the parking lot imaging the termination point of the  $\sim$ 12" diameter, metal corrugated storm water pipe. The top of the pipe is approximately 30" from the surface.
